# ENERGY SAVING ROI: THREE YEARS & BEYOND

SOLUTIONS FOR A STRESSED BUILDING  
STRUCTURAL LOAD & A POTENTIAL ICE-INDUCED  
ROOF COLLAPSE IN MICHIGAN

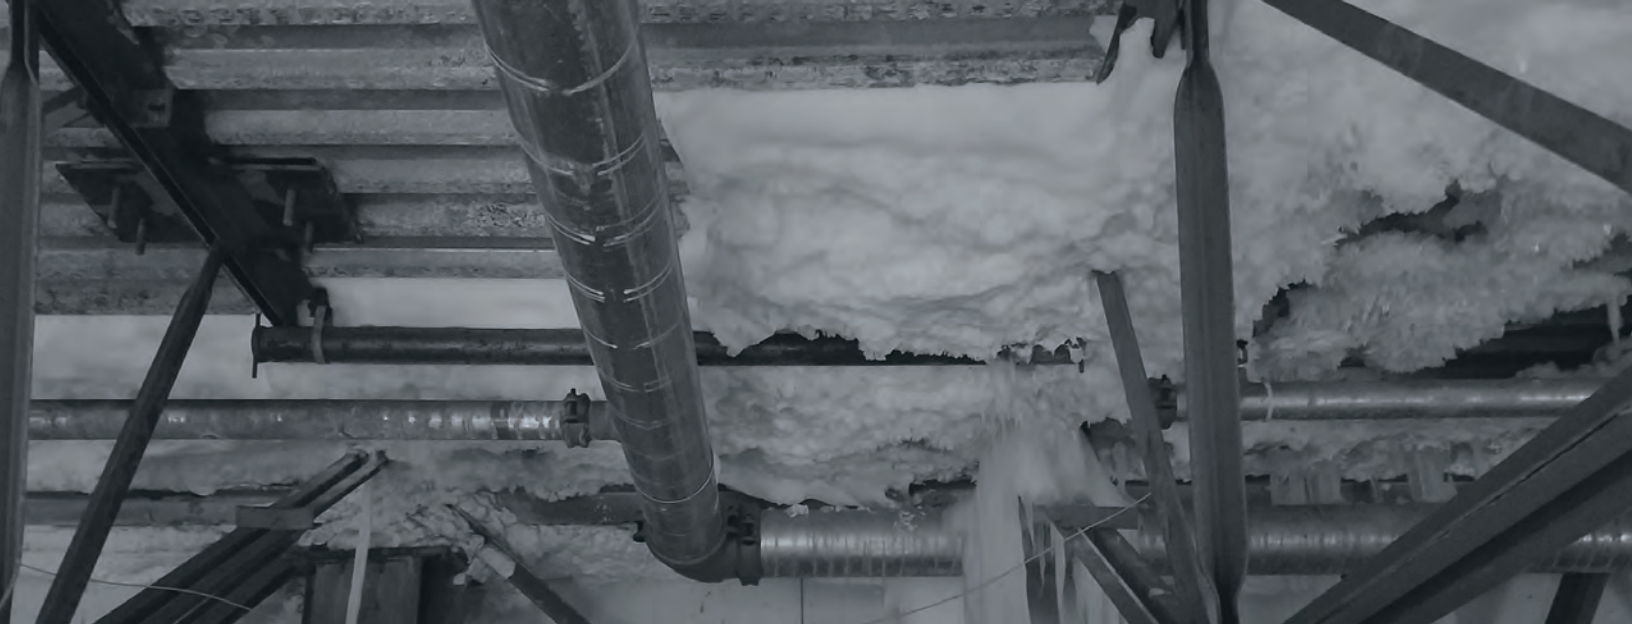
From the thermal imaging, we needed to confirm the roof deck status below the surface by drilling cores through the roof membrane to the roof deck and viewing the samples – we needed to cut core samples. We drilled 30 such core samples:

- 40 feet' into the field from the freezer perimeter, dense frozen insulation had resulted and the condition in the cooler was much worse with completely saturated insulation 80' around the perimeter. The entire loading dock area had no viable insulation remaining.
- Vapor Armour's forensic evaluation determined the loss of R-value of the insulation was the cause of the temperature issues the facility was experiencing.
- The loading dock perimeter was water saturated.
