# ENERGY SAVING ROI: THREE YEARS & BEYOND

SOLUTIONS FOR A STRESSED BUILDING  
STRUCTURAL LOAD & A POTENTIAL ICE-INDUCED  
ROOF COLLAPSE IN MICHIGAN

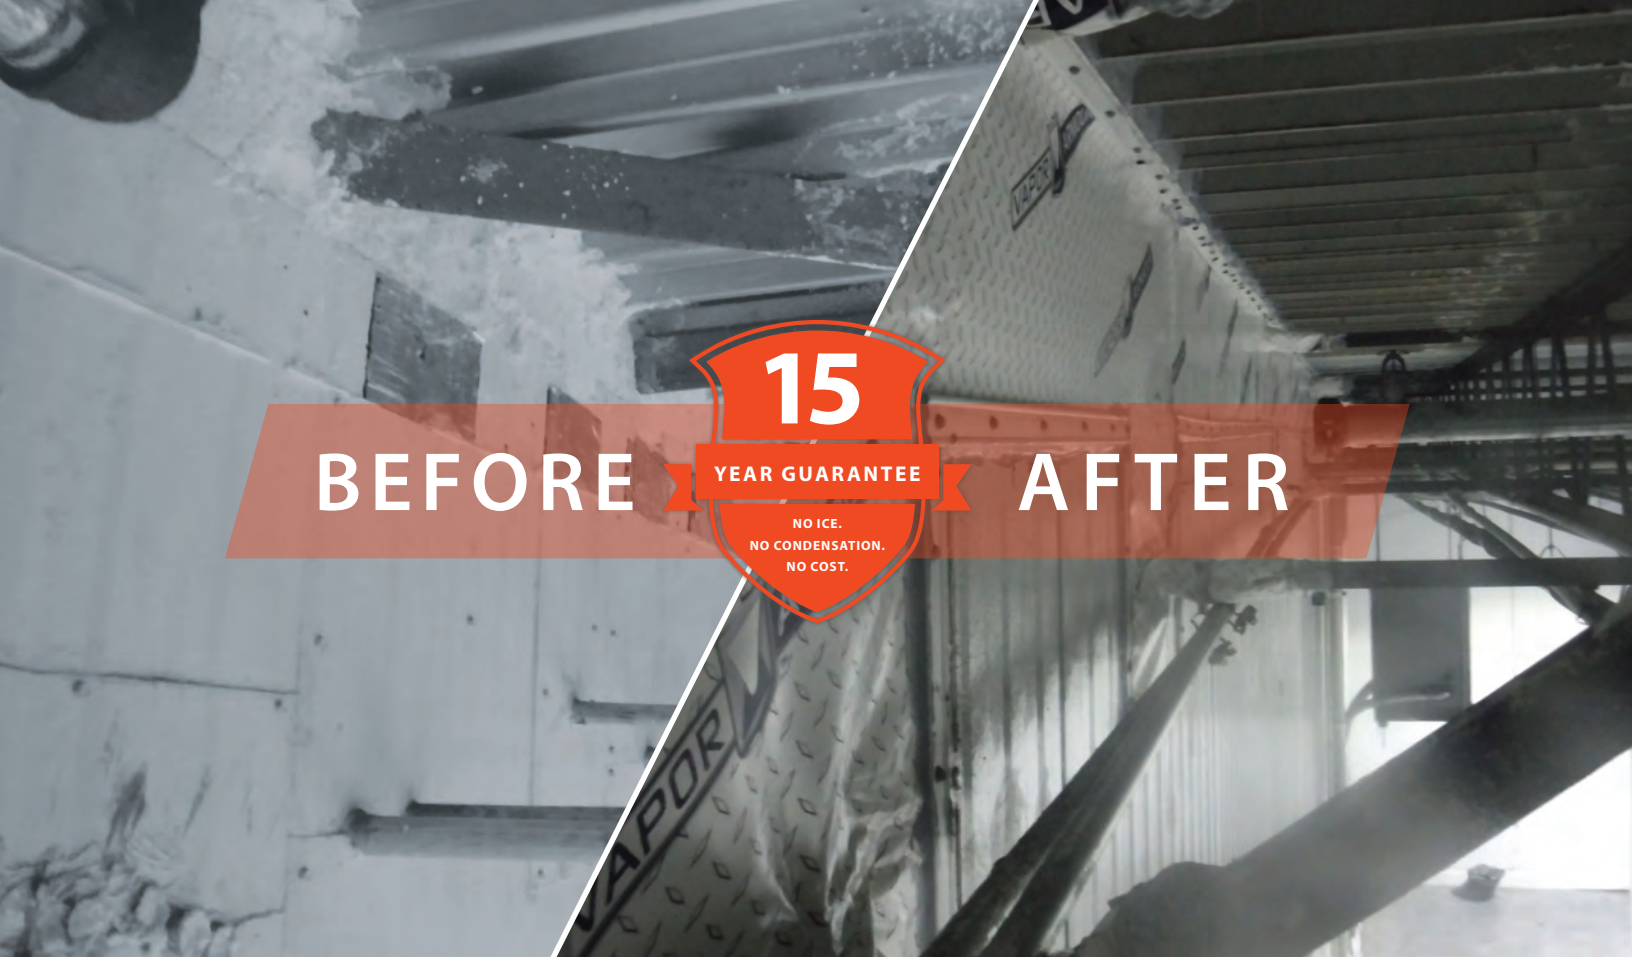
**BEFORE**      **AFTER**

severe icing and condensation in a distribution freezer and cooler

install Vapor Armour™ vapor barrier to the Freezer, Cooler and Loading Dock perimeters

install VA's patented expansion joint in the freezer portion of the building

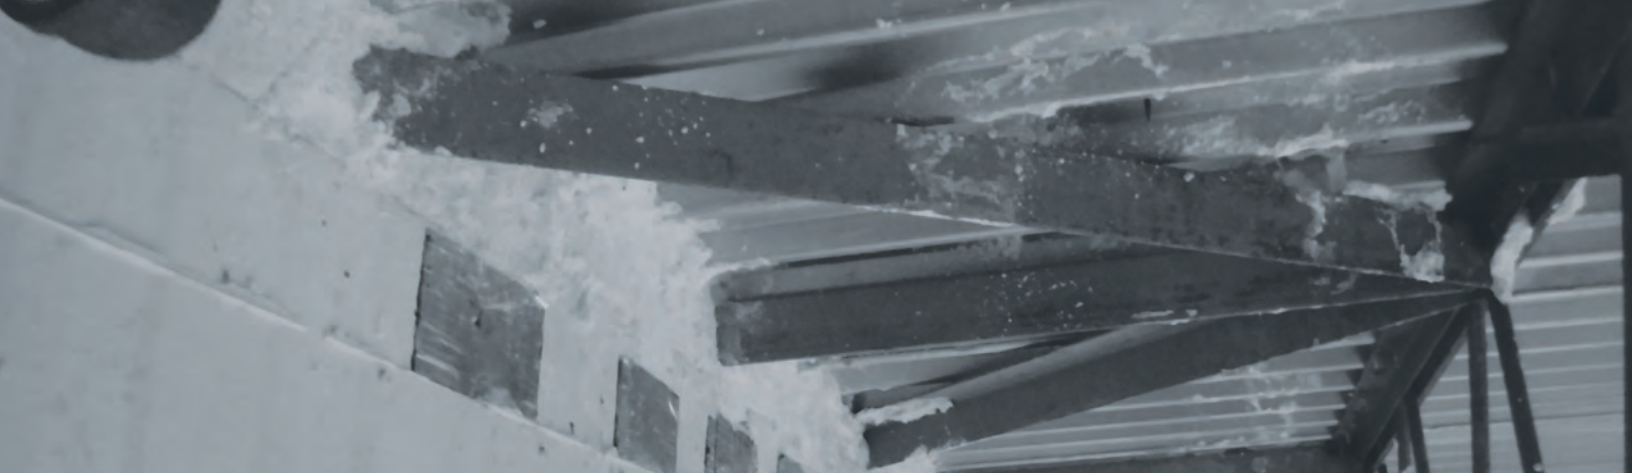
Vapor Armour performed a free, invasive Forensic Evaluation of the facility, and took Thermal Images and Core Samples to determine the extent of the issues.

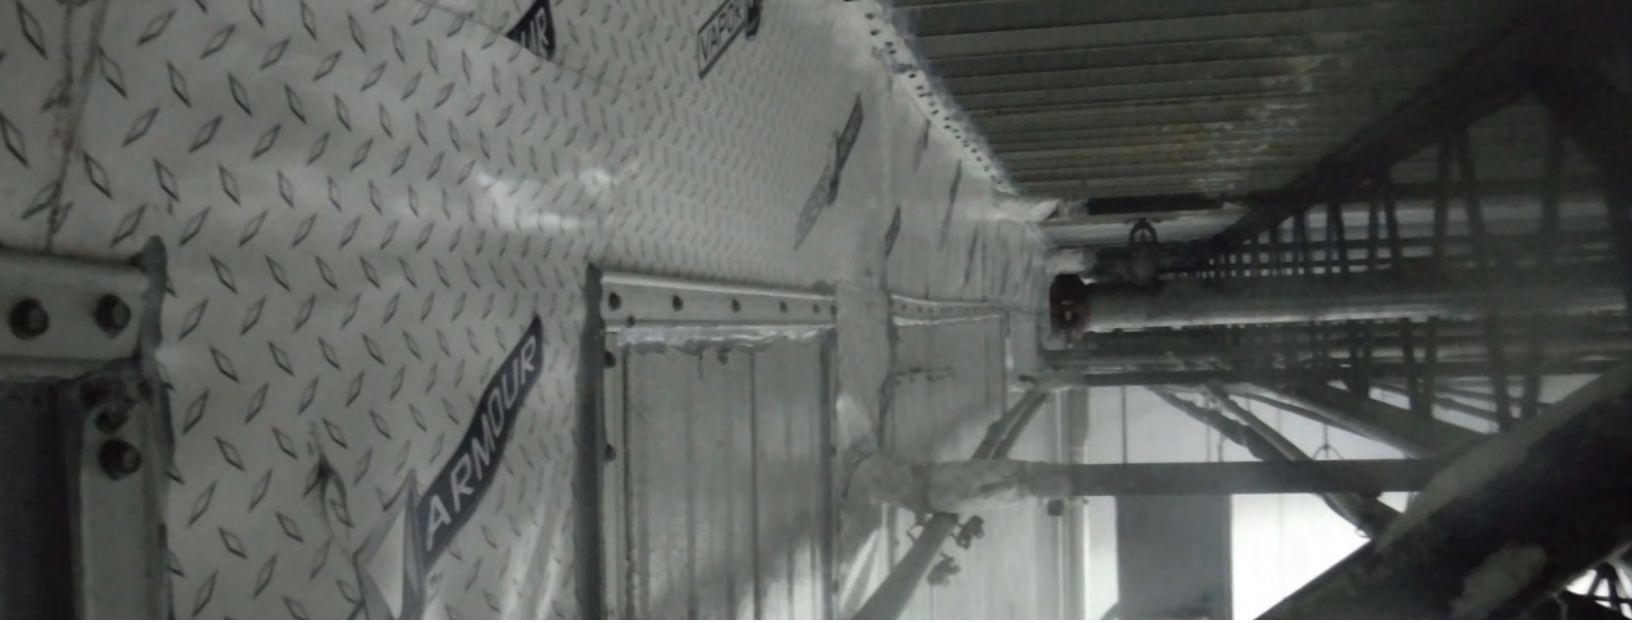
Vapor Armour's forensic evaluation determined the **FAILED PERIMETER VAPOR BARRIER** caused a **HIGH LOSS OF INSULATION R-VALUE** which in turn **CAUSED THE TEMPERATURE ISSUES** the facility was experiencing.
